## **Bugreport zur letzten Leiterplatten Auflage BOR 2N7000**

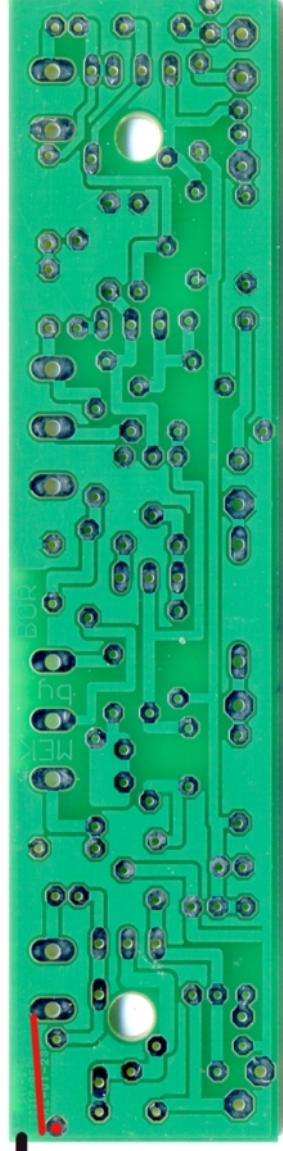
Beim suchen eines nicht funktionierenden Kundengerätes bin ich auf einen Herstellerfehler bei der BOR Leiterplatte der letzten Serie gestoßen. Durch die UL-Kennzeichnung des Herstellers im Layer Bottom wurde links oben in der Ecke die durchgehende Masseverbindung aufgetrennt und damit läuft die gesamte Schaltung nicht mehr.

When looking for a malfunctioning device clients, I came across a manufacturing defect in the BOR circuit board of the last series. By the UL marking of the manufacturer in the bottom layer, the continuous ground connection was separated in the upper left corner and thus the entire circuit is no longer running.

Durch UL Kennzeichnung wurde die Masse aufgetrennt  
The mass was separated by labeling UL

Abhilfe schafft hier eine kleine Brücke wie im Foto gezeigt. Die Platinen habe ich beim Hersteller jetzt reklamiert und bitte hier für eventuelles suchen oder Unannehmlichkeiten um Entschuldigung. Allerdings ist der Fehler ja nicht bei mir und hat mich auch 2 Neuaufbauten und 4h Arbeit gekostet.

If so, a small bridge as shown in the photo. The boards I have now reclaimed from the manufacturer and are looking here for eventuelles or Unannehmlichkeiten apologies. However, the fault's not with me and took me and two rebuilds and 4h work.

— Brücke löten  
soldering a bridge
